Bulletin Related To The Removal Of The Front Crankshaft Timing Belt Pulley **! URGENT !**

PERTINENT TO: 1998-2005 Audi V6 30 Valve Models With AHA, ATQ, APB, and BEL Engine Codes

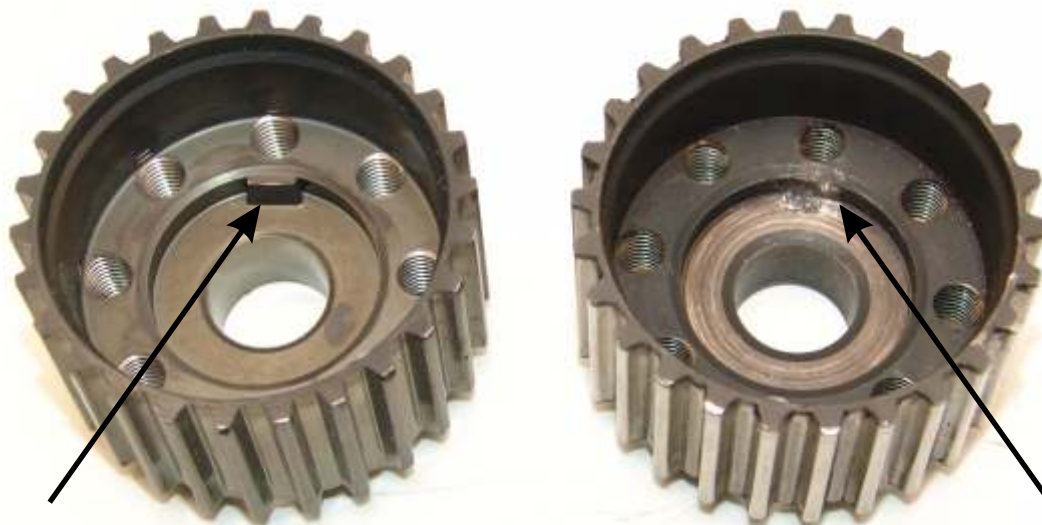
Both Audi and Volkswagen engines have a lower timing belt pulley that utilizes a minimally sized 'key' (see illustration below). This 'key' is devised to engage with the corresponding keyway in the crankshaft. It's been reported that while loosening the main crankshaft bolt existing friction, corrosion rust, or stray thread locking compound between the bolt head and pulley can inadvertently twist the small 'key' completely off the pulley or cause damage beyond safe reuse. Additionally, because the 'key' engages just the tip of the crankshaft, the crankshaft keyway can also be damaged. Due to the possibility of this damage, the installer may want to contemplate the immediate need for the removal of the lower crankshaft timing belt pulley to access the front crank seal.

BLAUfergnügen! Inc. has decided to stock the lower crankshaft timing belt pulley because of this problem (Item Number GG14000) and warns that by using a pulley that shows ANY signs of 'key' damage is unacceptable! If reinstallation is attempted with a damaged pulley 'key' or crankshaft keyway, the lower crankshaft timing belt pulley can easily fall out of time during main crankshaft bolt contraction, ultimately leading to catastrophic engine failure.

Note the photos below for indication on the location of the small key located on the lower timing belt pulley.

Original Key

Damaged Key

If there is no indication of oil leakage from the front crank seal, the installer may want to leave the lower crankshaft timing belt pulley as is, not risking damage. However, if the front crank seal is leaking and needs to be replaced, you have little option but to remove the pulley. Upon removal, it is crucial that you inspect the small 'key' protrusion found on the inside of the pulley for damage. You must also inspect the very front edge of the crankshaft keyway for damage. If the crankshafts keyway shows signs of damage and will no longer engage properly with the key on the pulley, short of complete replacement, it may be possible to locate a qualified welder and have the end welded up and ground to shape.
