BLAU fergnügen! Inc

Bulletin Related To The Removal Of The Front Crankshaft Timing Belt Pulley **! URGENT !**

PERTINENT TO: 1998-2005 Vw V6 30 Valve Models With AHA, ATQ, APB, and BEL Engine Codes

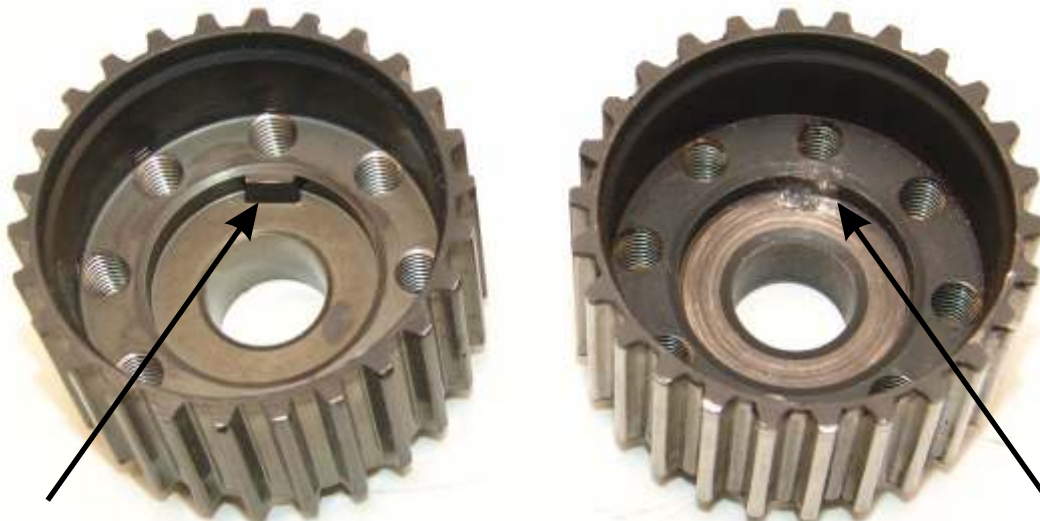
Both Audi and Volkswagen engines have a lower timing belt pulley that utilizes a minimally sized 'key' (see illustration below). This 'key' is devised to engage with the corresponding keyway in the crankshaft. It's been reported that while loosening the main crankshaft bolt existing friction, corrosion rust, or stray thread locking compound between the bolt head and pulley can inadvertently twist the small 'key' completely off the pulley or cause damage beyond safe reuse. Additionally, because the 'key' engages just the tip of the crankshaft, the crankshaft keyway can also be damaged. Due to the possibility of this damage, the installer may want to contemplate the immediate need for the removal of the lower crankshaft timing belt pulley to access the front crank seal.

BLAUfergnugen! Inc. has decided to stock the lower crankshaft timing belt pulley because of this problem (Item Number GG14000) and warns that by using a pulley that shows ANY signs of 'key' damage is unacceptable! If reinstallation is attempted with a damaged pulley 'key' or crankshaft keyway, the lower crankshaft timing belt pulley can easily fall out of time during main crankshaft bolt contraction, ultimately leading to catastrophic engine failure.

Note the photos below for indication on the location of the small key located on the lower timing belt pulley.

Original Key

Damaged Key

If there is no indication of oil leakage from the front crank seal, the installer may want to leave the lower crankshaft timing belt pulley as is, not risking damage. However, if the front crank seal is leaking and needs to be replaced, you have little option but to remove the pulley. Upon removal, it is crucial that you inspect the small 'key' protrusion found on the inside of the pulley for damage. You must also inspect the very front edge of the crankshaft keyway for damage. If the crankshafts keyway shows signs of damage and will no longer engage properly with the key on the pulley, short of complete replacement, it may be possible to locate a qualified welder and have the end welded up and ground to shape.
